Manhole Inspection Summary

Manhole # S07AA2016MH

Location Address: **5904 CROSS COUNTRY BLVD** Cross Street: **WESTERN RUN DR**

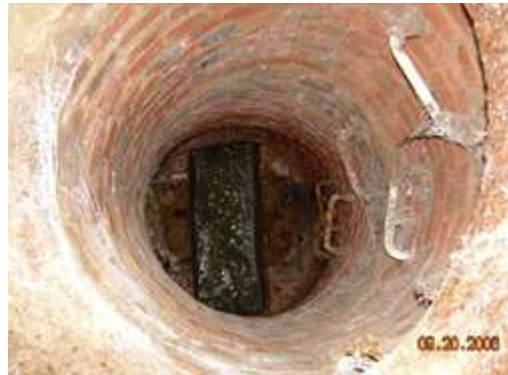
Top View

Adjustment and Corbel infiltration.
Evidence of surcharge - Bench debris.
Corroded steps.

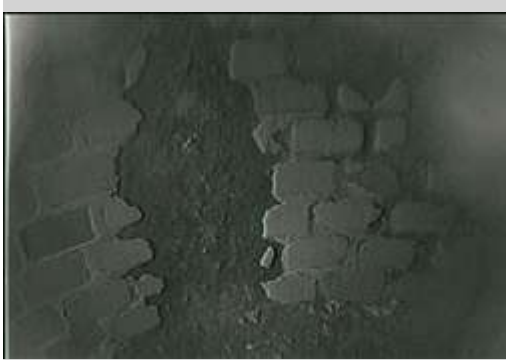
Defect

Barrel infiltration.

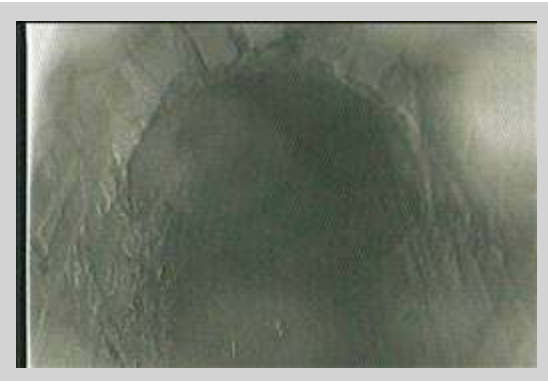
21 in. Circular Gravity Sewer Pipe In @ 6 O'Clock

Invert Depth: **13.05** (ft.) Flow Characteristics: **Fast**

Infiltration: **Evidence** Pipe Seal Cond: **Unknown**
